14. DESCRIPTION OF AMENDMENT/MODIFICATION (Organized by UCF section headings, including solicitation/contract subject matter where feasible.) The purpose of this Amendment is to insert Attachment 6 into solicitation FA3022-09-R-0003. (See Summary of Changes)							
Except as provided herein, all terms and conditions of the document referenced in Item 9A or 10A, as heretofore changed, remains unchanged and in full force and effect.							
15A. NAME AND TITLE OF SIGNER (Type or print)				16A. NAME AND TITLE OF CONTRACTING OFFICER (Type or print)			
				TEL: _____ EMAIL: _____			
15B. CONTRACTOR/OFFEROR		15C. DATE SIGNED		16B. UNITED STATES OF AMERICA		16C. DATE SIGNED	
(Signature of person authorized to sign)				BY _____		23-Mar-2009	
				(Signature of Contracting Officer)

Attachment 6- Inspection Report of Water Tower Facility 355, dated 3/13/2008, pages 1-22

200,000 Gallon "Facility 355 Tank" Elevated Water Storage Tank Inspection Report

Columbus Air Force Base, MS

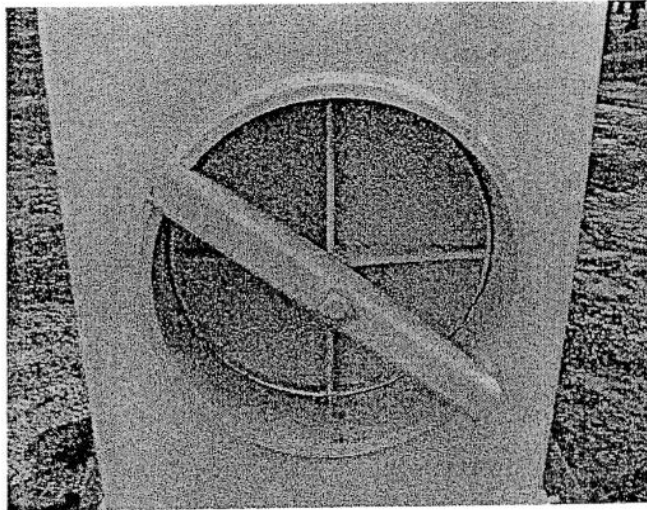
Photo #1 Current access meets OSHA standards.

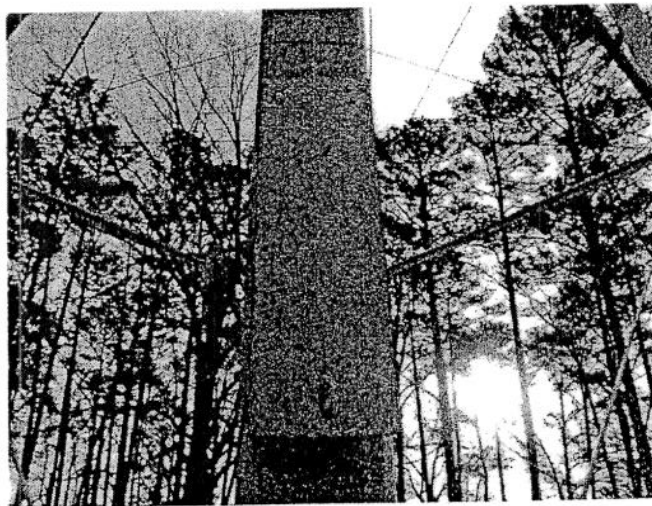
The leg access ladder does not contain a proper ladder gate to prevent unauthorized access onto the ladder.

Photo #2 Access leg ladder gate does not provide adequate protection.

The exterior access ladders comply with current OSHA Standards and AWWA guidelines, but do contain a recalled safety climb system. The dome ladder also contains a safety climbing device that is not secure. This tower is not equipped with an inadequate ladder gate to prevent unauthorized access. **It is recommended to install a proper ladder gate to the access ladder and replace the access and dome ladder safety climbs with cable climbs.**

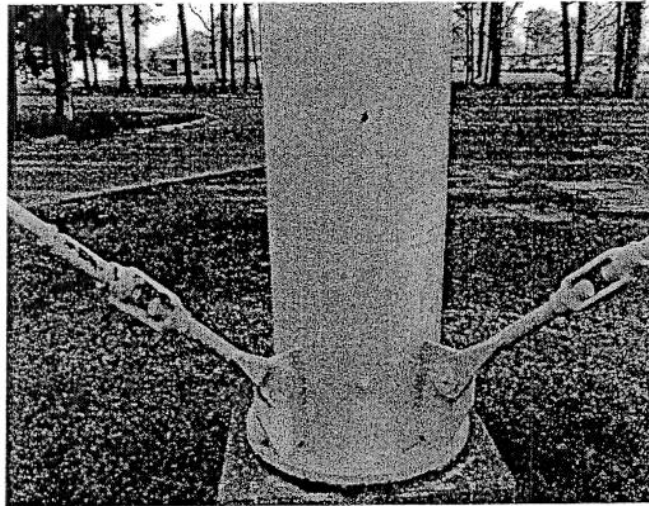
The exterior coating system is in good to fair condition. The appearance of the coating system is fair. The exterior coating system exhibits chalking, mildew growth, areas of corrosion, and delaminating paint. The adhesion taken on the legs and riser is poor.

Photo #3 Exterior Coating System on the leg and wind rod connection.

- The exterior coating system is past the end of its life expectancy and should be properly removed and the lead based coatings disposed of. A complete containment and 3 coat system should be utilized immediately.

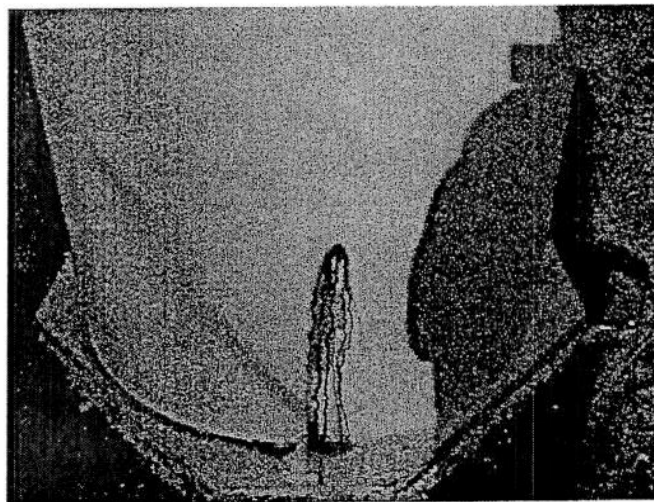
The interior coating system on the tank riser is in extremely poor condition with heavy blistering and corrosion on 80% of the wet riser. More leaks will begin to form over time if immediate action is not taken.

Photo #4 Exterior Coating System where a leak has formed from interior corrosion.

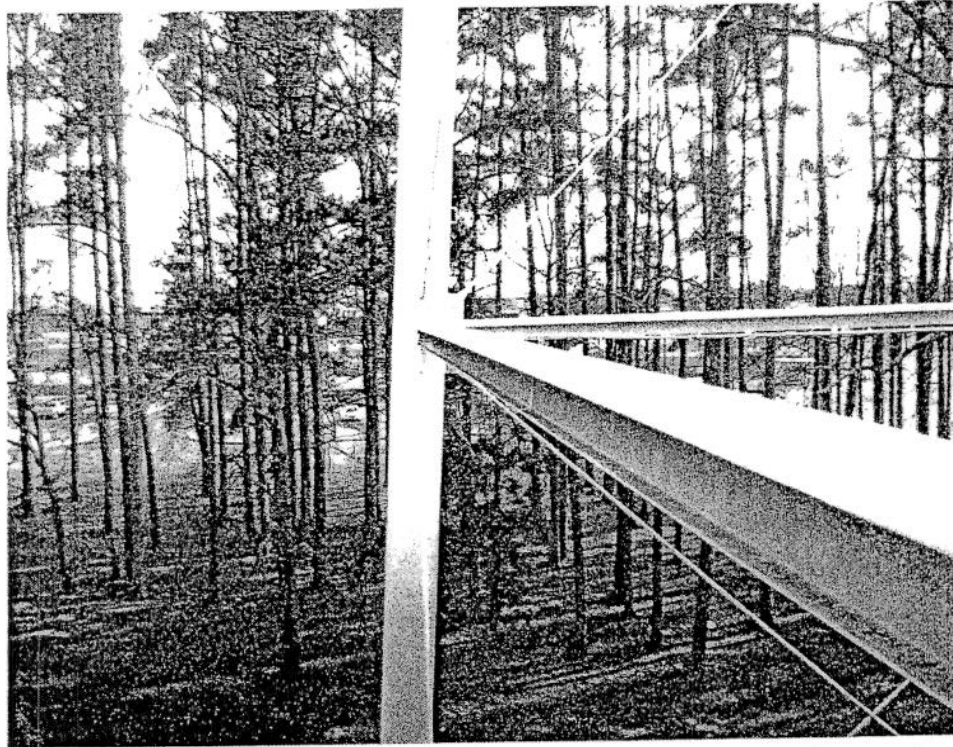
Photo #5 Exterior Coating System on the strut exhibits mildew and mold growth.

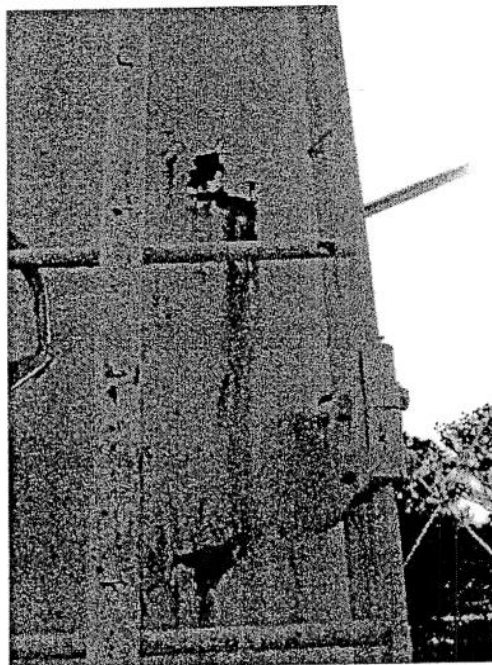
Photo #6 Exterior Coating System on the access ladder leg.

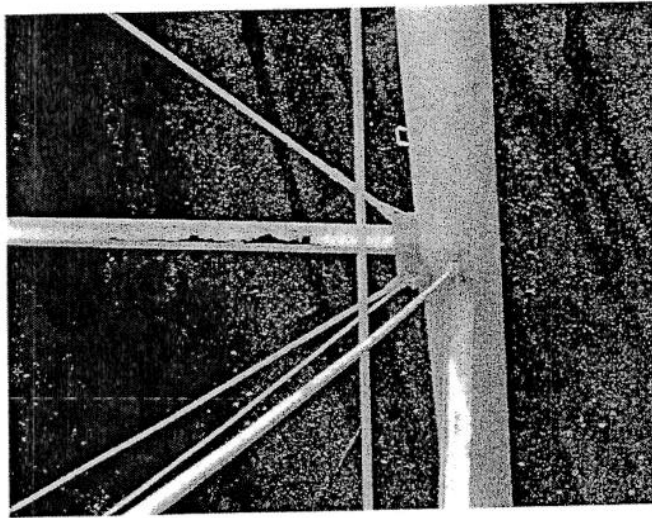
Photo #7 Exterior Coating System on the struts.

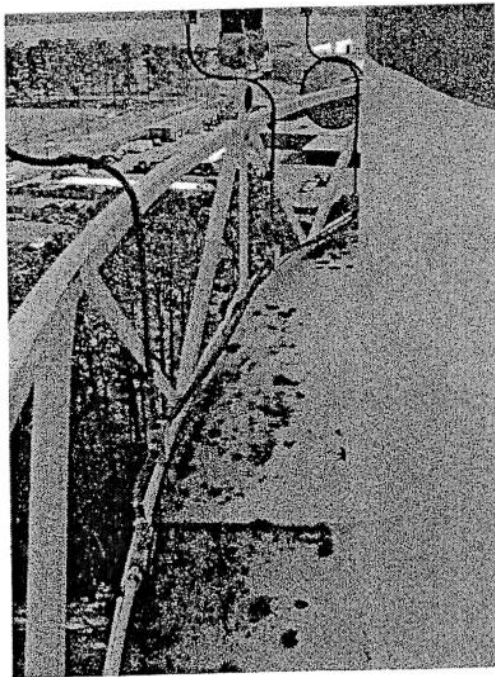
Photo #8 Exterior Coating System with heavy corrosion on a large area of the balcony.

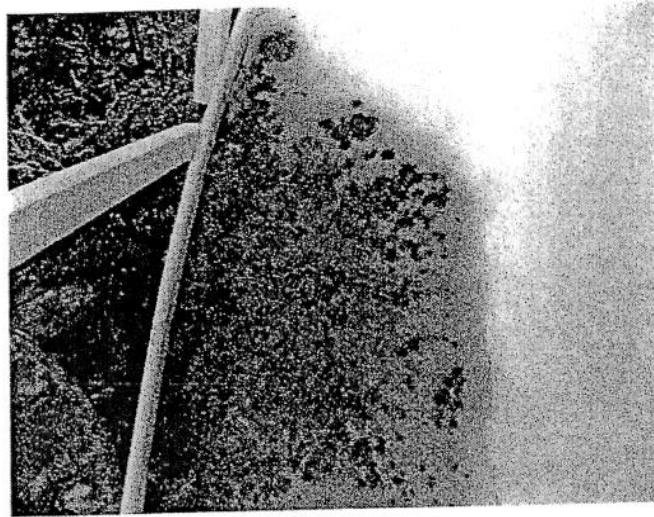
Photo #9 Exterior Coating System where heavy corrosion exist on the balcony floor.

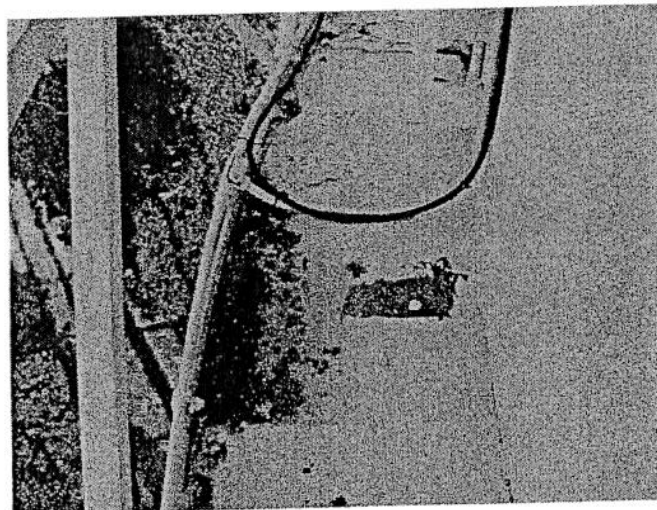
Photo #10 Exterior Coating System on the balcony are beginning to fail.

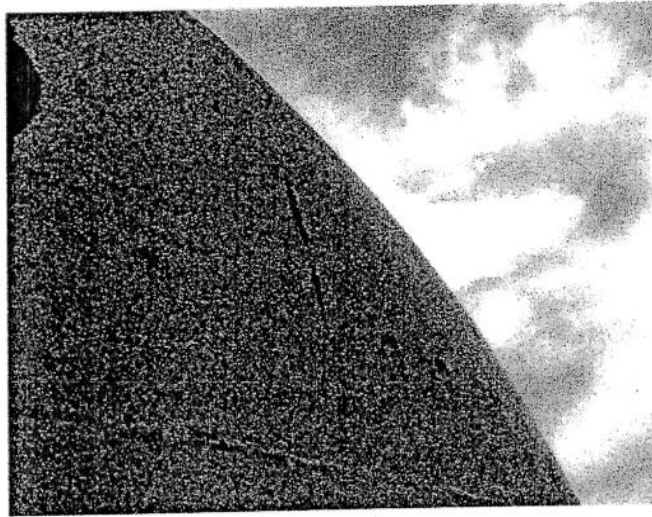
The exterior coating system on the tank sidewalls and roof are in fair coatings condition. The catwalk is in fair to poor condition with large areas of corrosion and steel pitting. The exterior coating system overall exhibits chalking, areas of corrosion; mildew growth and flaking.

Photo #11 Exterior Coating System on the sidewall shows failure and flaked coatings.

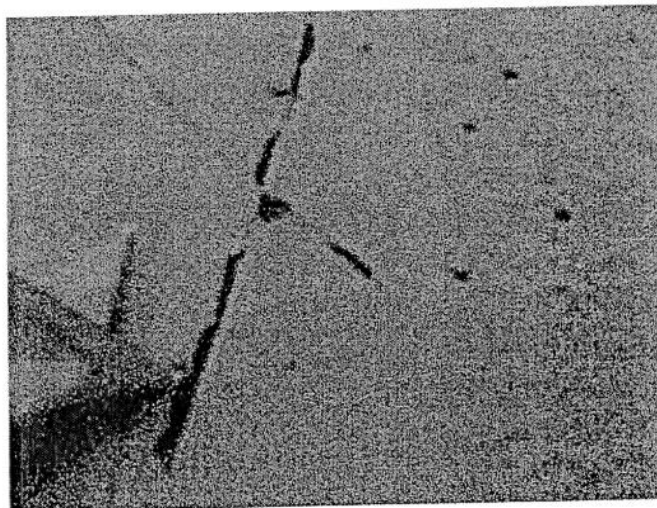
Photo #12 Exterior Coating System showed poor adhesion.

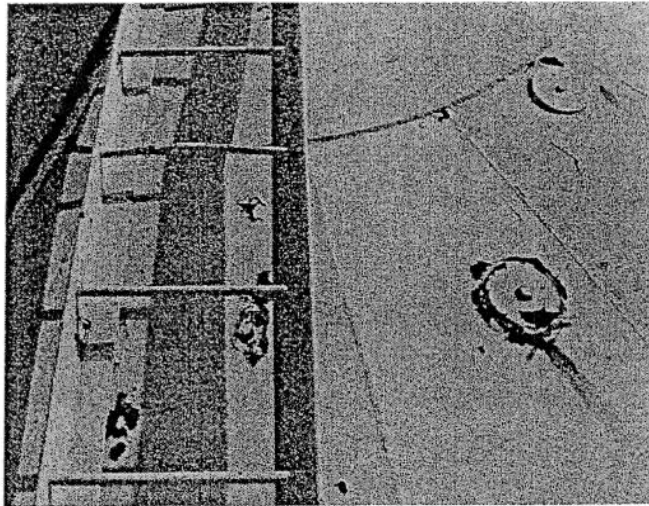
Photo #13 Exterior Coating System on the dome and knuckle is beginning to fail.

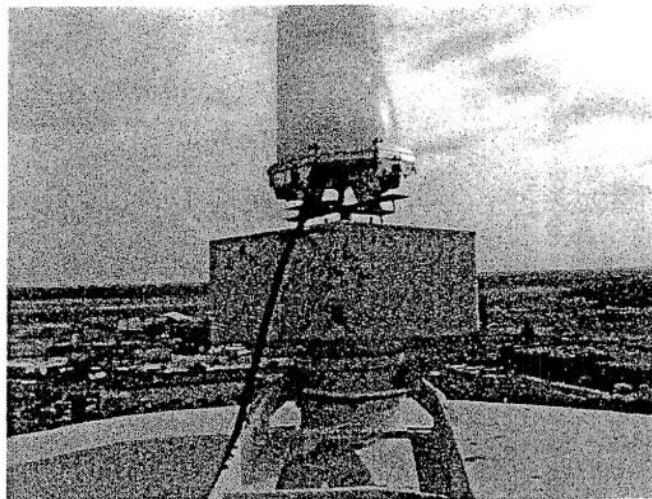
AWWA guidelines require that a tank have a vent, which is both freeze-proof and insect-proof, on the top of the tank to prevent contamination from birds, bats and insects. These guidelines also suggest the screen be protected from direct contact with the elements. This tower is equipped with a noncompliant vent. The current vent and vent screen provide adequate water tight protection. It is recommended to replace the small vent with a new aluminum 24" vent.

Photo #14 Existing vent should be removed and replaced with a minimum 12" diameter.

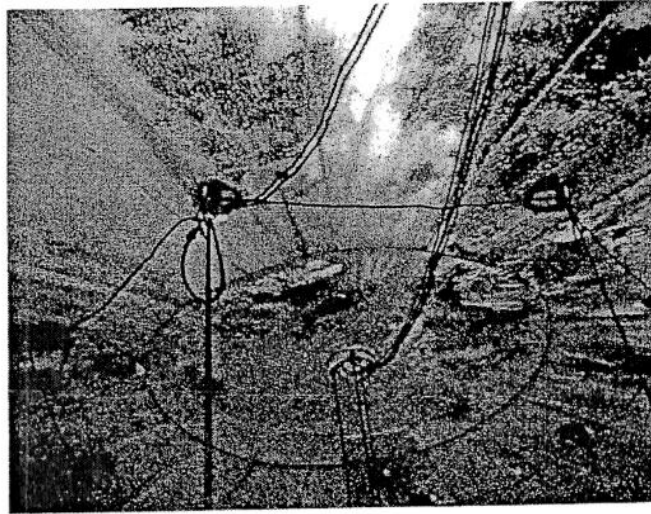
The interior coating system on the roof plates and the area above the high water level is in poor coatings condition with flash rust and heavy corrosion on 35% of the substrate. The interior coating system exhibits corrosion around areas of the dollar plate and above the high water level.

Photo #15 Interior Coating System around the dollar plate is on 35% of the sunstrate.

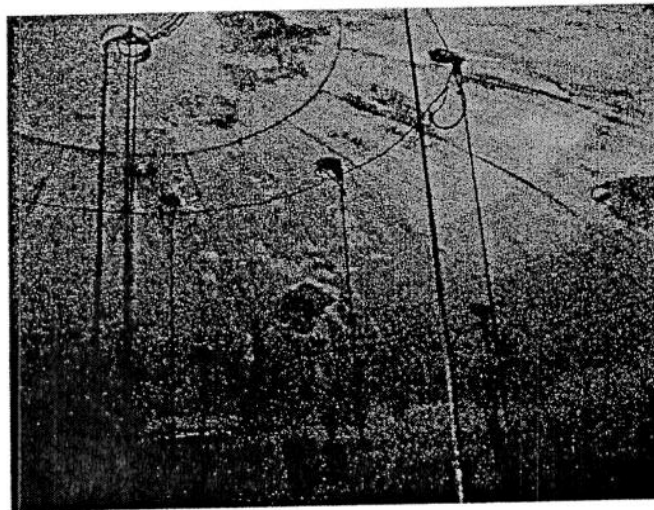
Photo #16 Interior Coating System around the dollar plate.

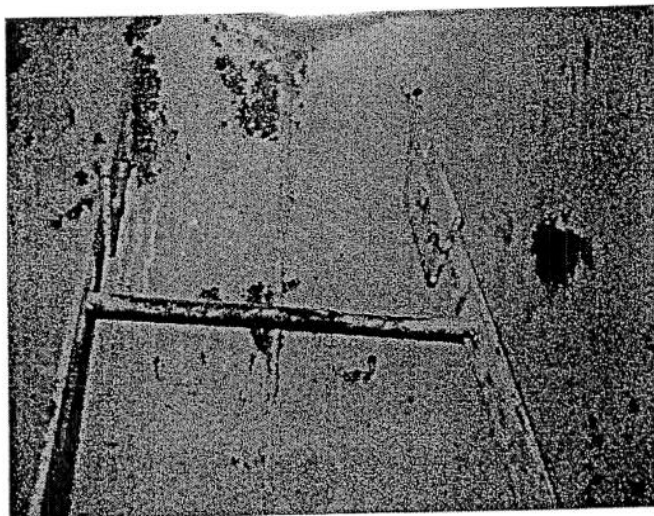
Photo #17 Interior ladder above the high water level.

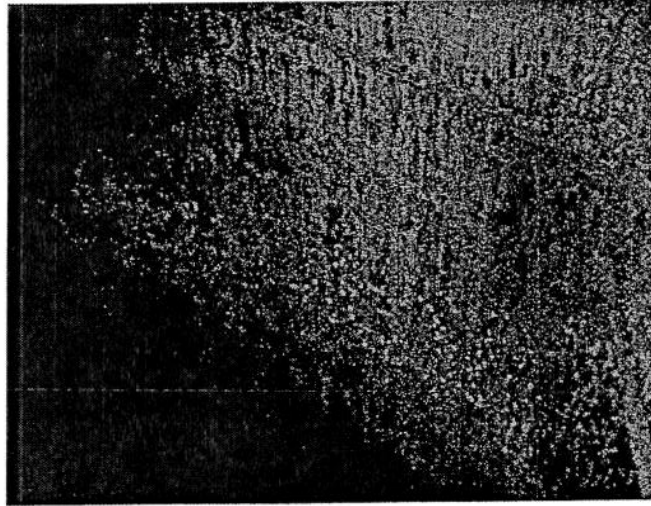
Photo #19 Interior Coating System on the sidewall has failed and is causing heavy corrosion.

- The interior coating system has completely failed and is not providing the substrate any corrosive protection below the water level. The interior coating system will need repair welds and a complete SSPC-SP #10 blast.

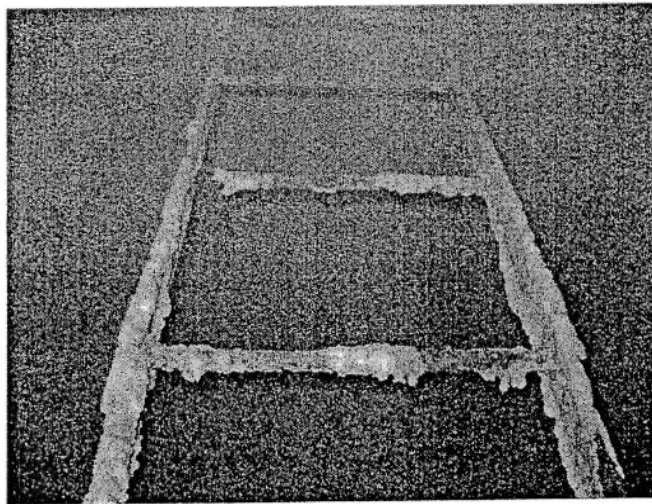
Photo #20 Interior ladder exhibits heavy corrosion.

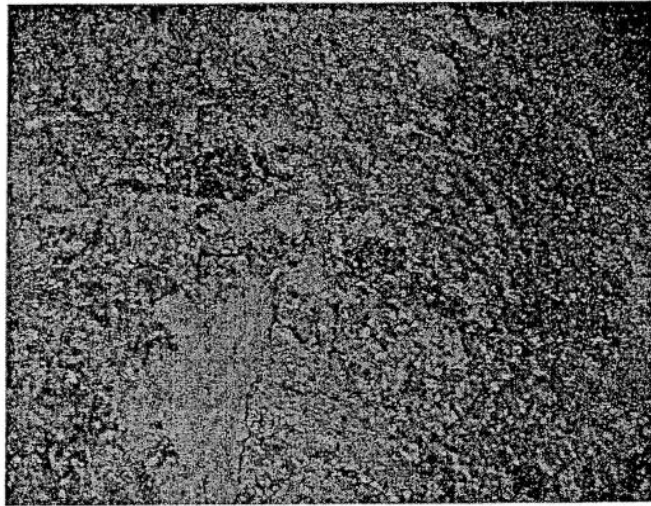
Photo #21 Interior sediment and debris during the washout inspection.

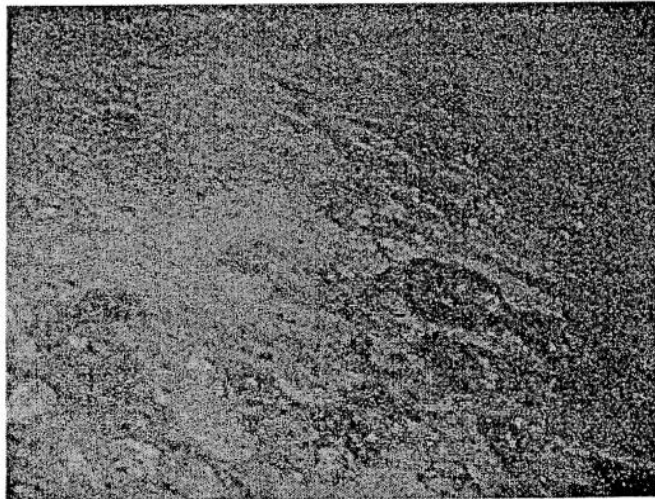
Photo #22 Interior Coating System where coatings failure and a grease film is present.

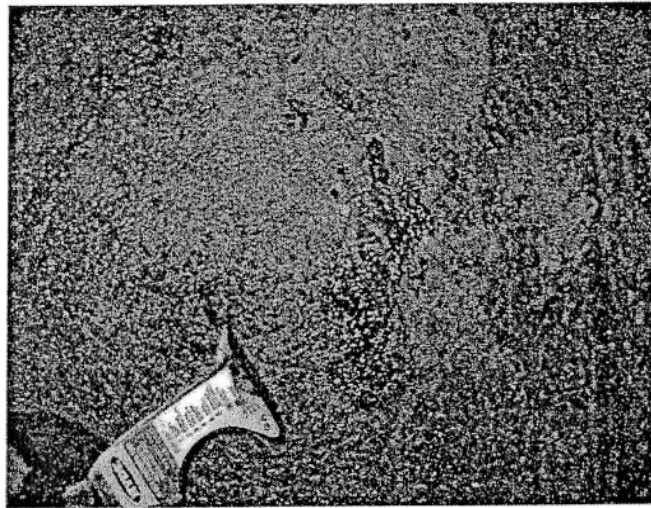
Photo #23 Interior Coating System where blistering is present.

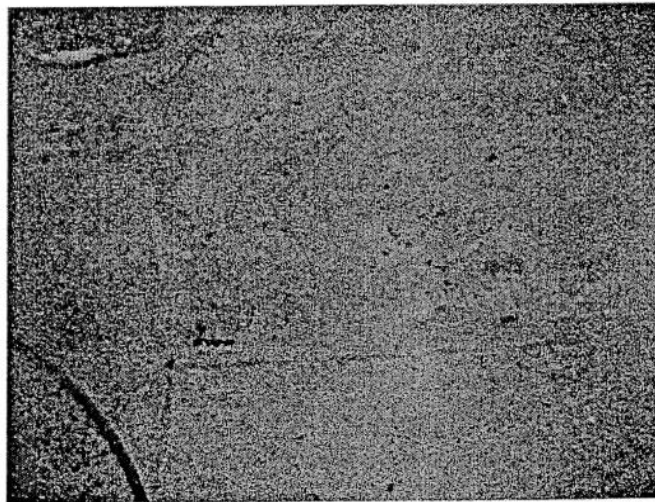
The interior coating system on the tank bowl is consistent with the coatings failure on the sidewall. Heavy debris from the anodes was removed during the interior washout inspection.

Photo #24 Interior bowl coating system is beginning to fail.

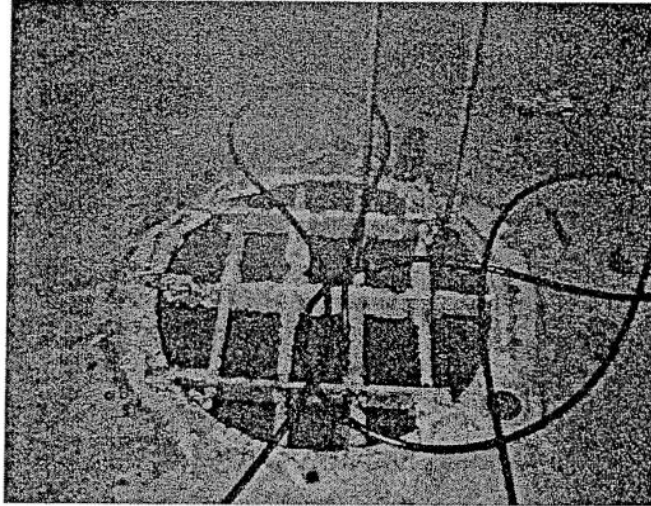
Photo #25 Interior coating and corroded riser grate.

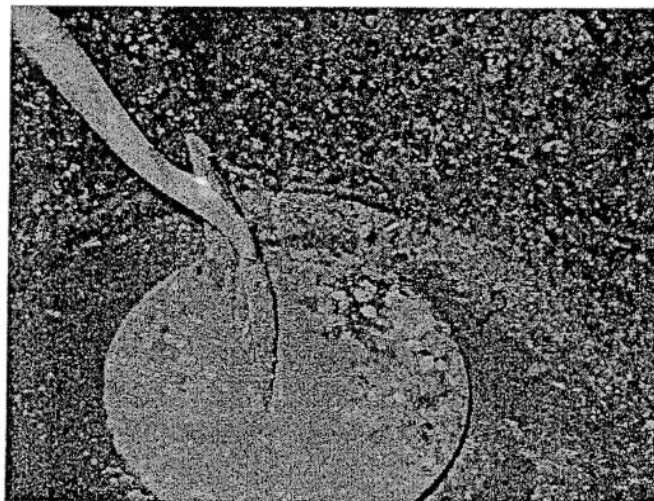
Photo #26 Interior coating system in the riser during the washout inspection.

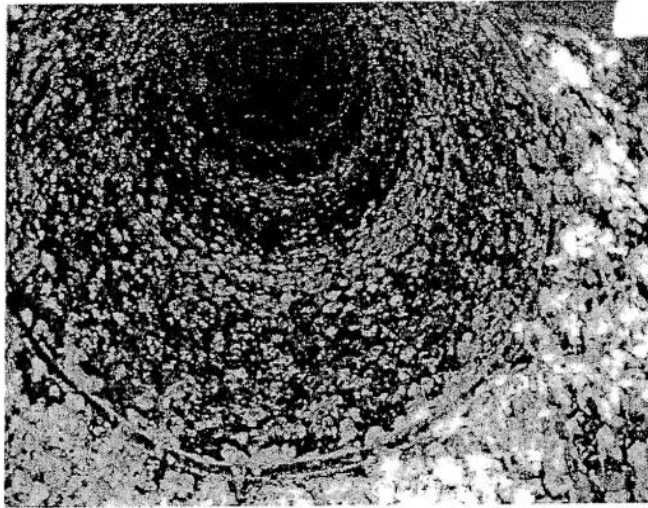
Photo #27 Interior coating system in the wet riser. Heavy blistering and corrosion present.

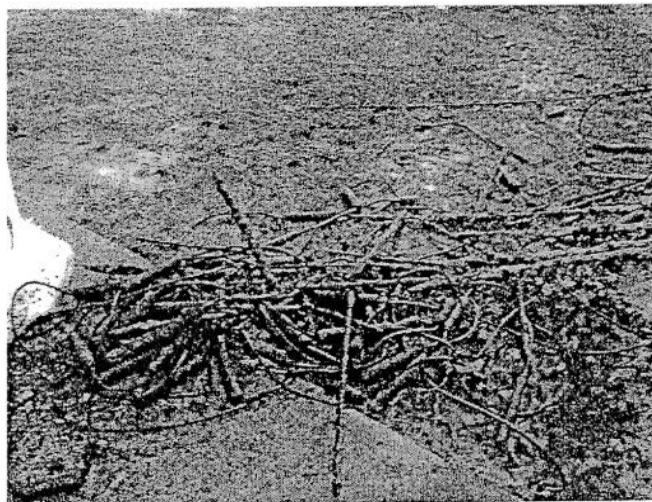
Photo #28 Debris removed from the interior of the tank.
